[Docket No. FAA-2022-0891; Project Identifier AD-2022-00585-A,E,R]

Airworthiness Directives; Various Airplanes, Helicopters, and Engines

ACTION: Notice of proposed rulemaking (NPRM).

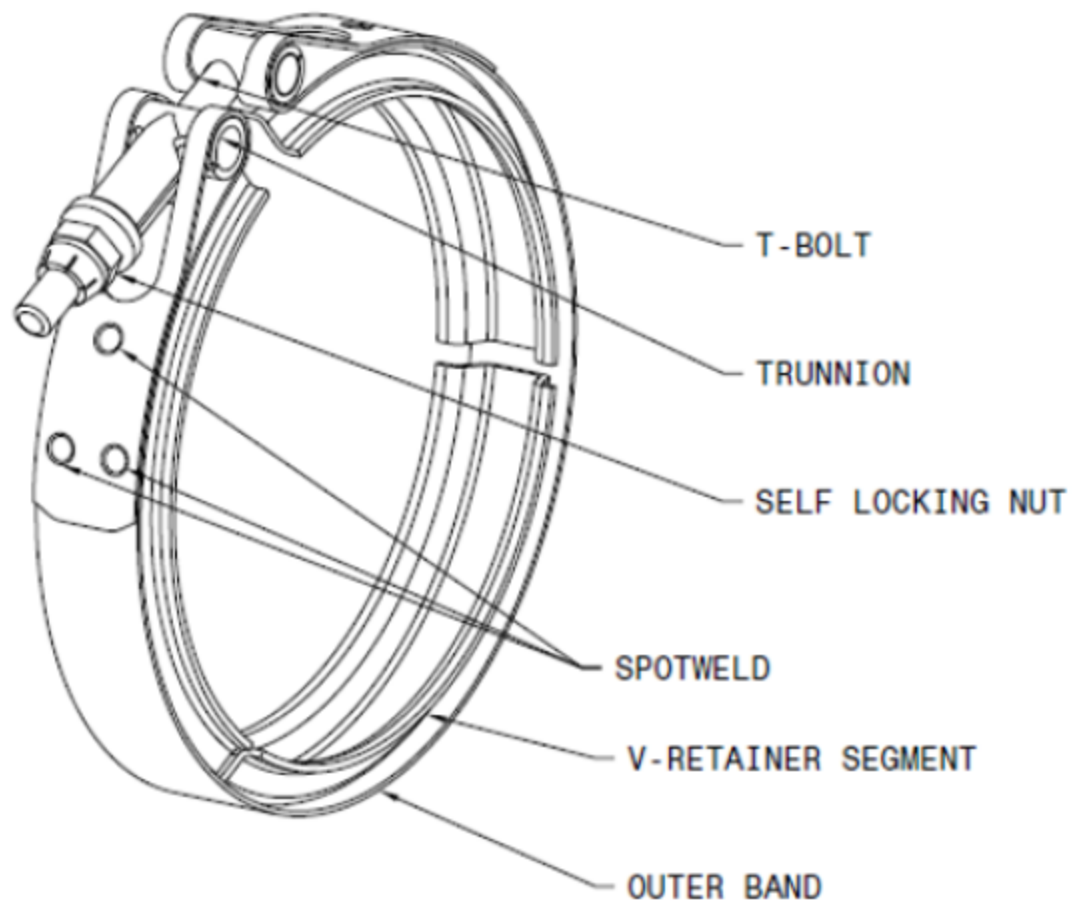
Figure A

The final report concluded that the common denominator in the incidents and accidents reviewed is the spot-welded, multi-segment exhaust tailpipe v-band coupling (see Figure A). These couplings come in either two or three segment varieties. The segments are the number of v-retainer segments, which are attached to the outer band via spot welds. Although multi-segment exhaust tailpipe couplings can also be riveted, the riveted couplings do not create an unsafe condition.

Spot-welded, multi-segment exhaust tailpipe v-band coupling

The majority of the events studied by the working group indicated fatigue failure of spot-welded, multi-segment exhaust tailpipe v-band couplings as a result of stress corrosion cracking that originated at or near a spot weld. This is the same unsafe condition identified in the other v-band coupling AD actions previously referenced. The data studied by the working group contained evidence of pre-existing cracking of the couplings, known embrittlement at the spot weld locations simply due to that manufacturing method, and outer band cupping on the multi-segment couplings (which is the result of age, over-use, and potential over-torquing). The working group also found that many of the couplings had safety wire across the bolt end. The safety wire could be helpful if there was a bolt or nut failure (extremely rare events) or the nut was missing. However, the safety wire was of no value when the failure was transverse band cracking and total separation at the spot weld. The data studied by the working group indicated many accidents were due to v-band couplings that were of the multi-segment, spot-welded design, when used in a specific location (the tailpipe to the turbocharger exhaust housing flange on turbocharged reciprocating engine-powered aircraft).

- Repetitively inspecting the spot-welded, multi-segment exhaust tailpipe v-band couplings annually, regardless of the hours time-in-service (TIS) accumulated on the v-band coupling; and
- Establishing a life limit for the spot-welded, multi-segment exhaust tailpipe v-band couplings by removing them from service every 500 hours TIS.

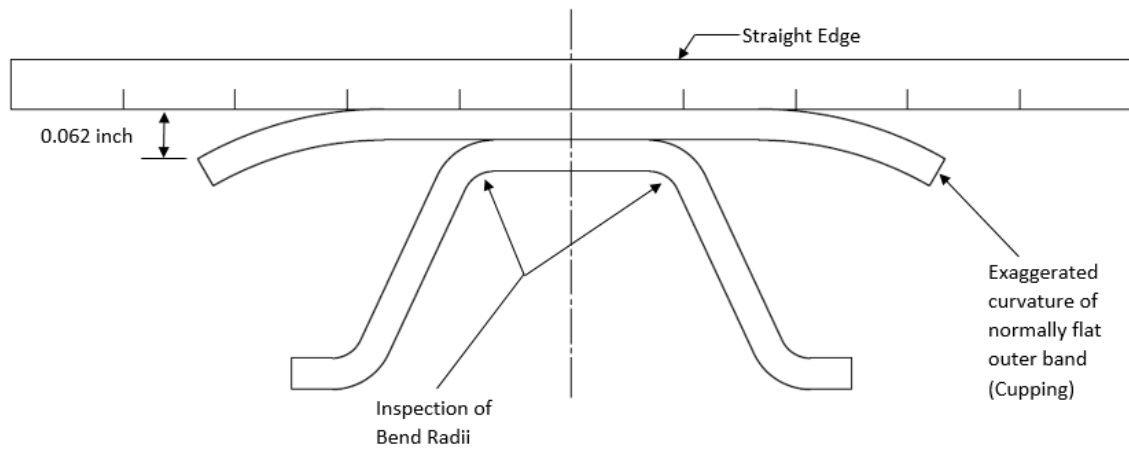
Figure 1 to paragraph (k)(1)(iii) – Inspection Depiction

(4) Inspect the v-band coupling outer band for cupping, bowing, and crowning as depicted in figure 1 to paragraph (k)(1)(iii) of this AD. If there is any cupping, bowing, or crowning, before further flight, remove the coupling and, instead of the inspections in paragraphs (j)(5) through (7) of this AD, do the inspections in paragraph (k) of this AD.

(iii) Visually inspect the flatness of the outer band using a straight edge. Lay the straight edge across the width of the outer band as depicted in figure 1 to paragraph (k)(1)(iii) of this AD. If the gap between the outer band and the straight edge exceeds 0.062 inch, before further flight, remove the v-band coupling from service and install a new v-band coupling.

(v) Visually inspect the bend radii of the v-retainer coupling segments, throughout the length of the segment, as depicted in figure 1 to paragraph (k)(1)(iii) of this AD, for cracks. If there are any cracks, before further flight, remove the v-band coupling from service and install a new v-band coupling.
